**TOWN OF OAKVILLE  
HERITAGE IMPACT ASSESSMENT  
for  
1475 LAKESHORE ROAD EAST  
Oakville, Ontario**

SBA Project No. 21040

**FINAL**  
**August 19<sup>th</sup> 2022**

Stevens Burgess Architects Ltd.

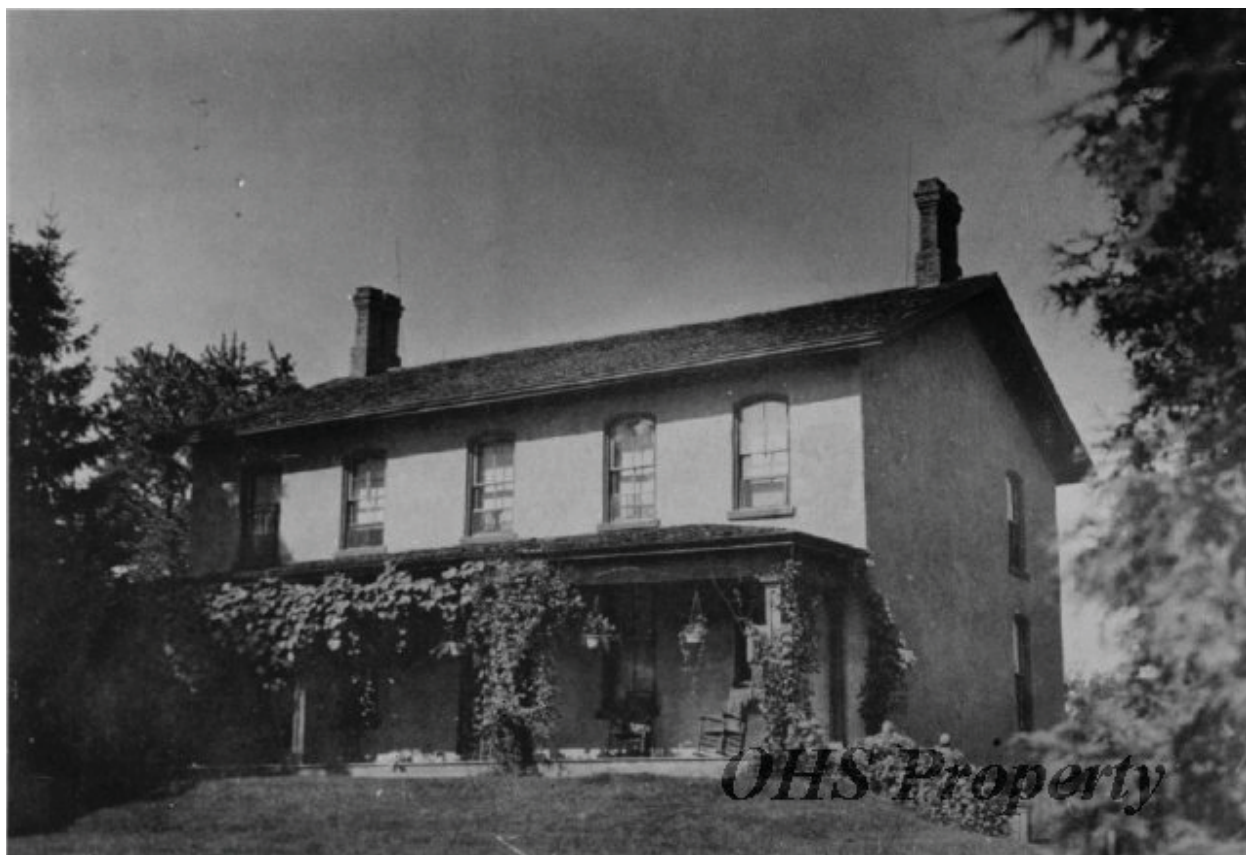
**Figure 31:** 1475 Lakeshore Road East with original porch, arched 2<sup>nd</sup> floor window heads, 2<sup>nd</sup> chimney and 2 windows on east gable (n.d)  
Credit: Oakville Historical Society

- the removal of the front verandah and its replacement with a Neoclassical entablature;
- the curvatures at the 2<sup>nd</sup> floor window heads were squared off and shutters were added;
- the reduction in height of the window above the new entablature;
- the removal of the twin (second) chimney at the east gable end;
- the reconfiguration of the interior from two square rooms on the west side into one large room with a fireplace in the centre of the long west wall;
- the addition of central heating; and
- the construction of a two-storey rear addition that altered the footprint from a square to a t-shape.

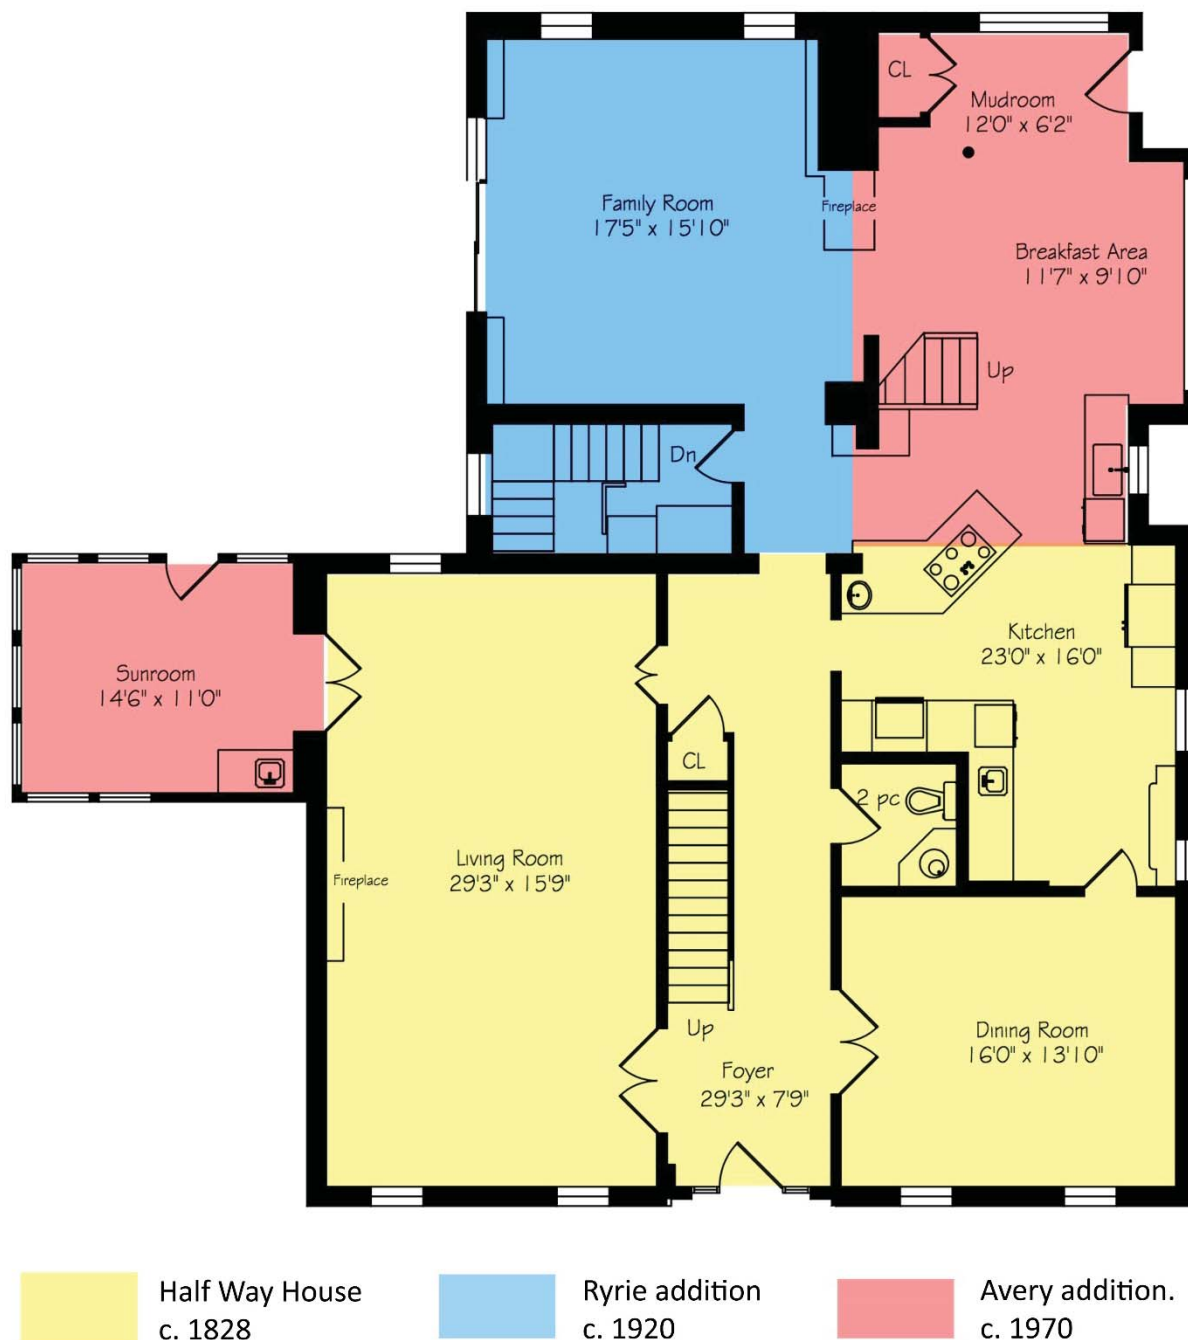
**Figure 52:** Ground Floor Plan showing original house and later additions  
Credit: Client-provided floor plan with SBA annotation

The house reflects three different periods of construction: the original inn constructed by Griggs c. 1828; the addition of a two-storey addition/tail at the north (rear) elevation constructed under Ryrie's ownership during the same period as other alternations to the interior and exterior occurred c. 1920s; and the addition of a one-storey rear addition and interior alterations under the ownership of Avery c. 1970s. The rear (north) elevation of the original house has been largely obscured by the rear one and two-storey additions. These changes are reflected in **Figure 52**.

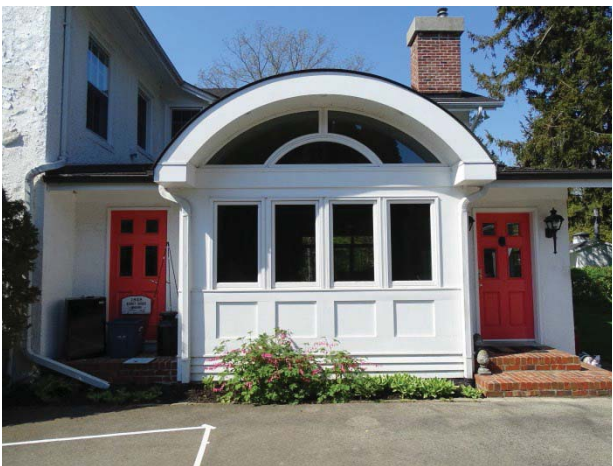
**Figure 53:** East Elevation of One-storey Rear Addition

There are two doors on the east elevation located two steps above grade and flanking the arched transom and bay window within the breakfast area. The design of the transom may have been chosen to reflect the transom at the front entrance. An Oakville Historical Society Plaque denoting the house as the former Halfway House constructed in 1828 by Barnet Griggs is located on the closed door to the left of the central window. The addition also includes a newer brick chimney.

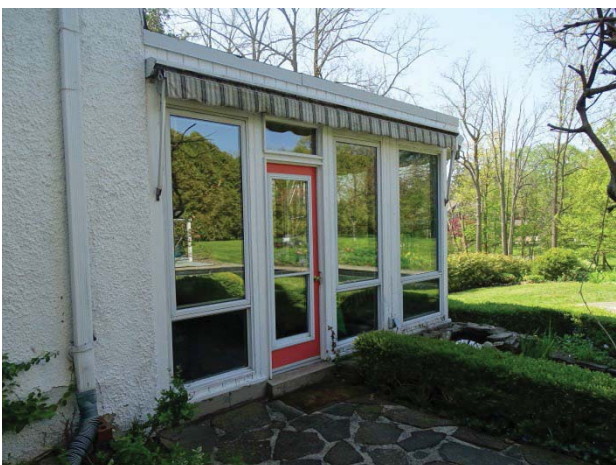
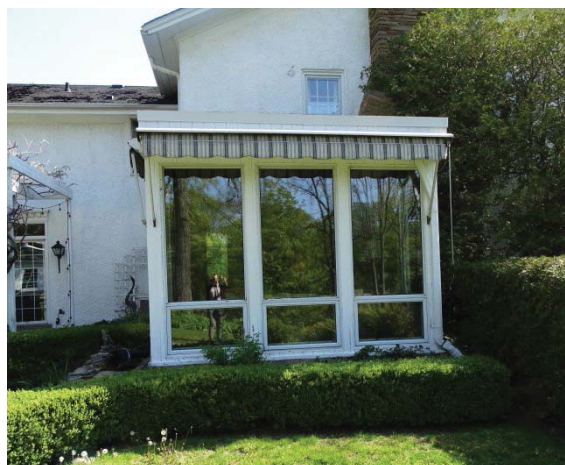
**Figure 56:** West elevation of sunroom addition

There is a glassed contemporary sunroom addition on the west elevation that partially obstructs the original chimney as well as the former ground windows (assumed). The addition is not visible from the front due to its location and the presence of large trees next to the front elevation.

All of the additions are in fair to good condition. The re-modeling and additions by both Ryrie and later Avery included the neo-classical elements that remain extant.

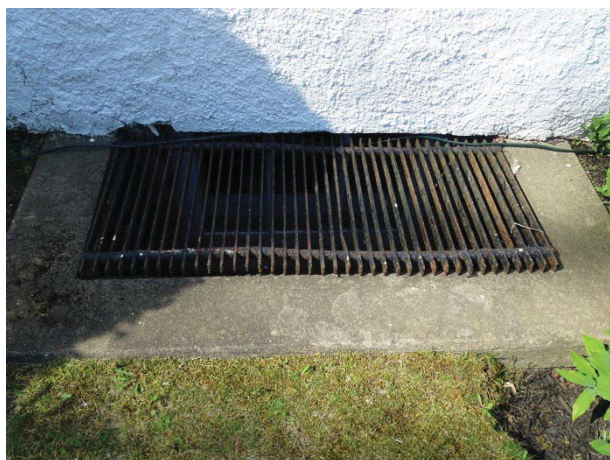
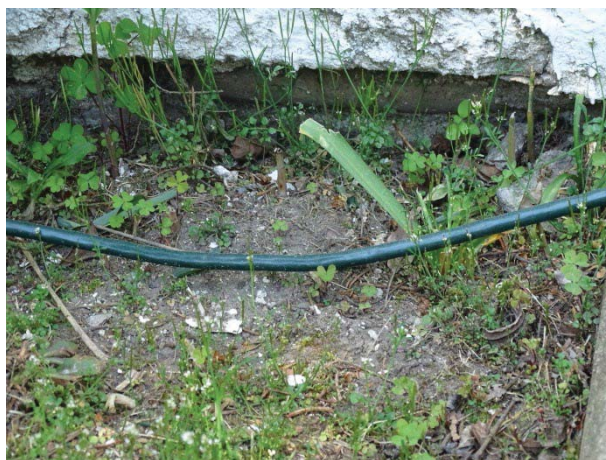
**Figure 59:** Grate at foundation

The concrete foundation beneath the original house most likely dates to the time when the house was moved to its current location on the property c. 1918. Generally little or no foundation is visible as the stucco extends to grade in many locations. No damage was noted. Iron grates above the basement windows were constructed with a concrete surround and generally look to be in fair to good condition.

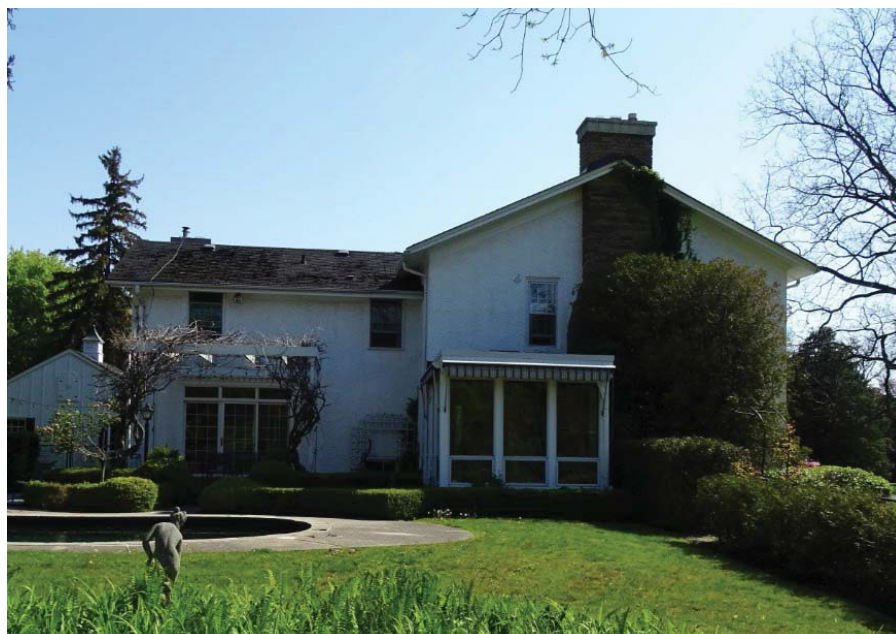
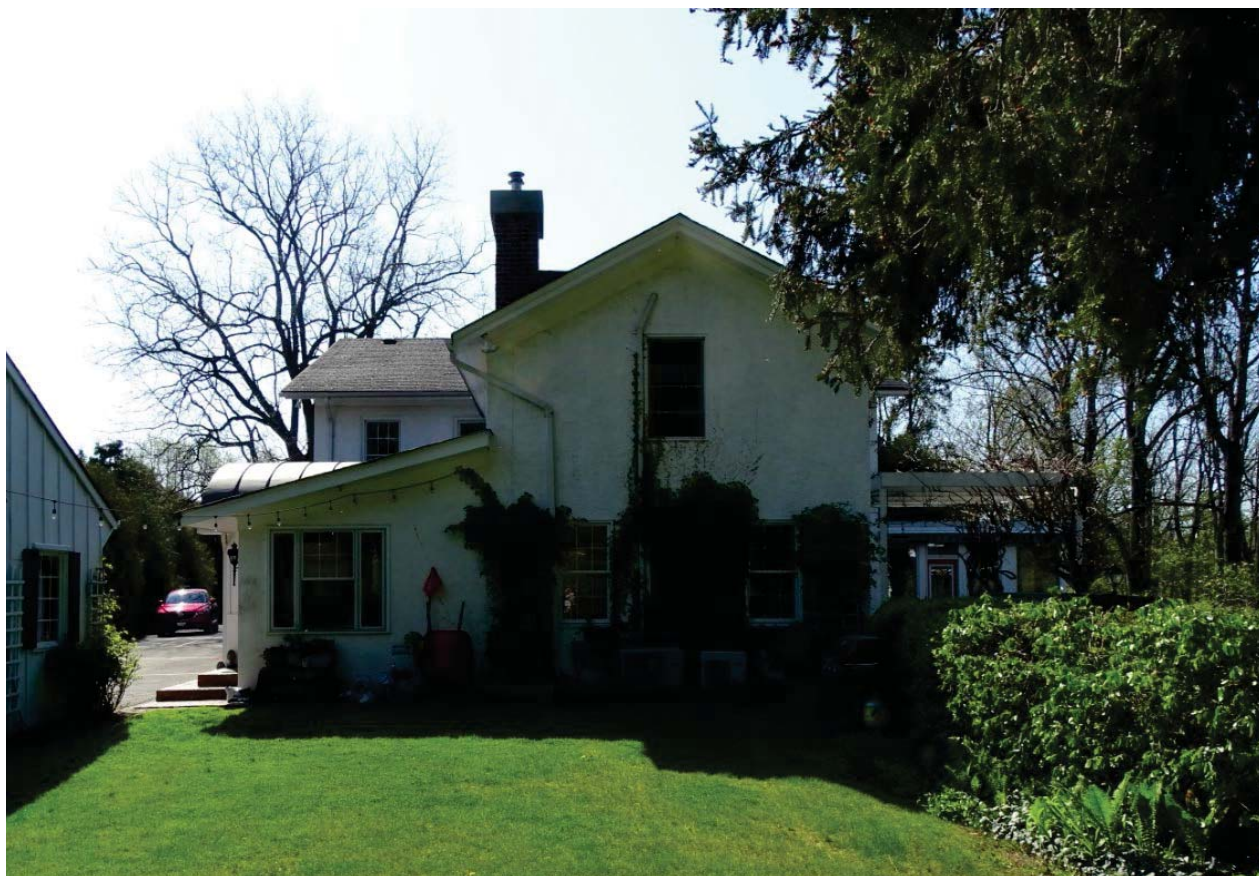
**Figure 60:** West Elevation

The exterior building envelope of the original structure is in fair condition. The house inclusive of the rear additions are clad in white stucco. There are signs of stucco damage/failure inclusive of peeling stucco and holes within the exterior finish. The growth of vines is evident on the north elevation of the rear two-storey addition as well as brick chimney on the west gable.

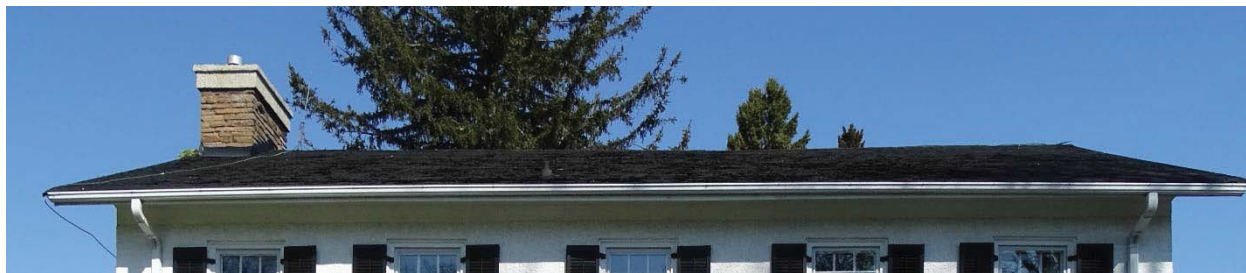
**Figure 64:** Roof at Front Elevation

The sloped gable roof of the Main House is clad in black asphalt shingles with white prefinished aluminum gutters and downspouts. The asphalt roofs of the original house and rear additions all appear in poor condition, the shingles are lifting and curling. The roof of the rear one-storey addition has a substantial barrel-vaulted roof, clad in metal (possibly copper) that appears in good shape with metal fascias and soffits. The soffits and fascia (bead board) of the original house and rear two-story addition are painted wood and appear in good condition.

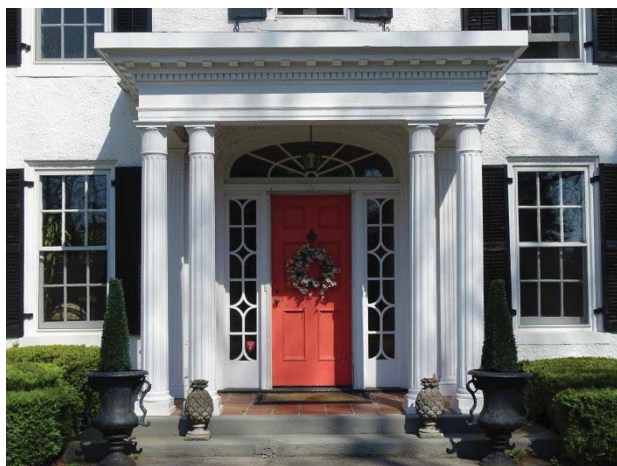
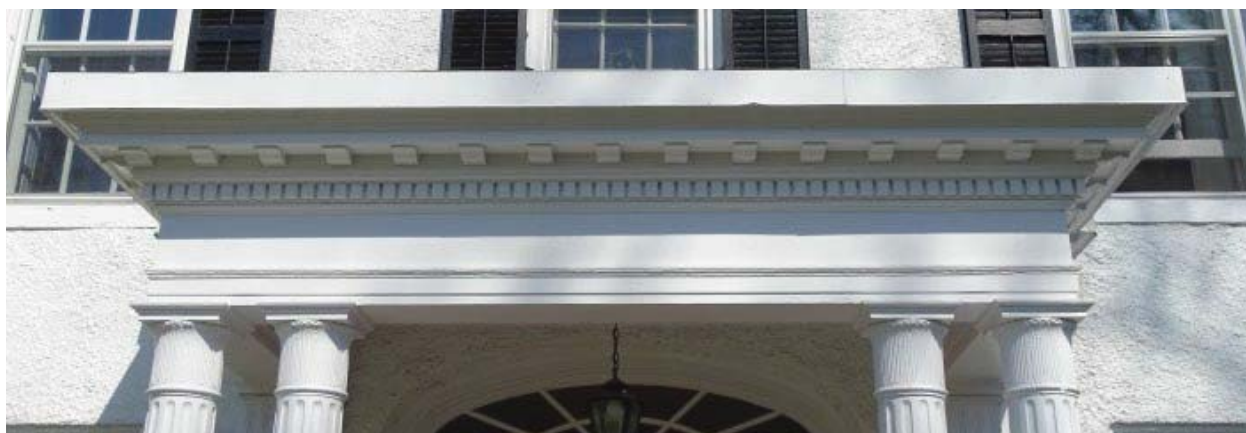
**Figure 69: Front Entrance**

The entrance rises slightly above grade with two shallow cement steps and a red brick landing. Generally the entirety of the entrance portico is in a state of good repair though sanding/stripping of the paint may be required during the next painting campaign. The decorative portico is topped with a band of dentils beneath a flat roof with a white prefinished metal (assumed aluminum) fascia. The state of the flat roof was not revealed.

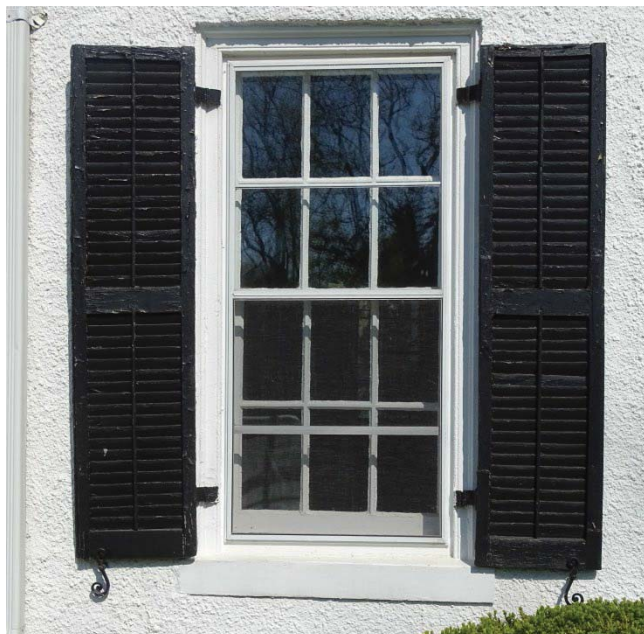
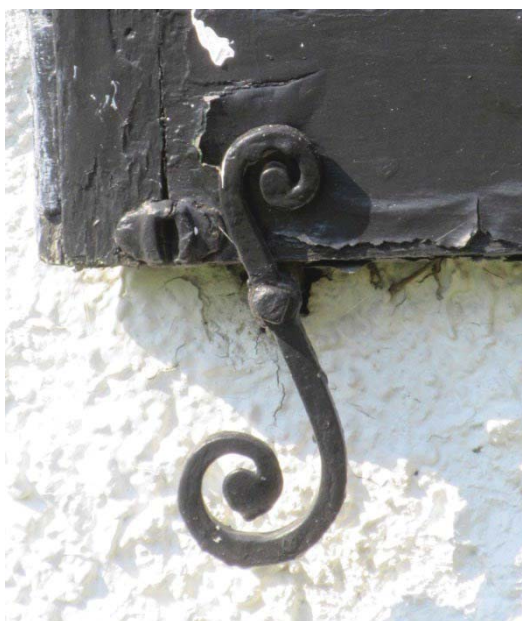
**Figure 71:** Lower Window at Front

The windows on the front elevation are symmetrical with four, six-over-six (assumed double hung) wood windows on either side of the front portico and a shorter six-over-six wood window above the front entrance. The windows have white painted wood frames (paint is beginning to peel), white prefinished aluminum storms with screens and the sills may have been coated in a smooth stucco at some point. Black wood shutters frame all the windows and are held in place with decorative wrought iron hardware. The painted windows appear in fair to good condition (operability not confirmed). The black painted wood shutters may need to be sanded and/or stripped prior to their next painting as areas of bare paint are beginning to show and some the shutters are a bit misaligned.

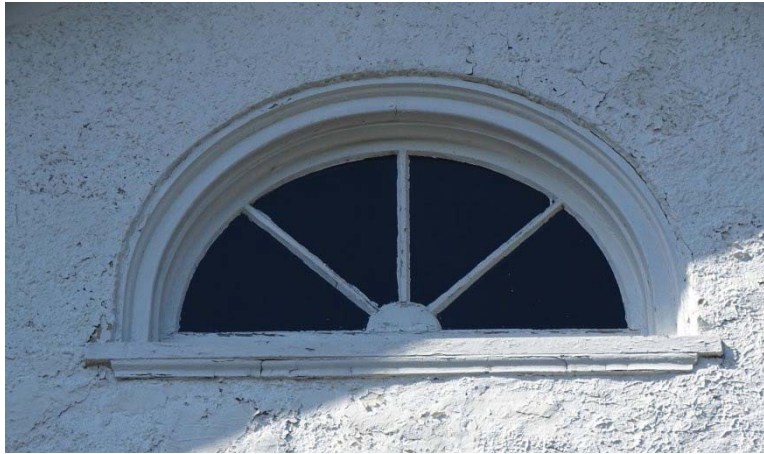
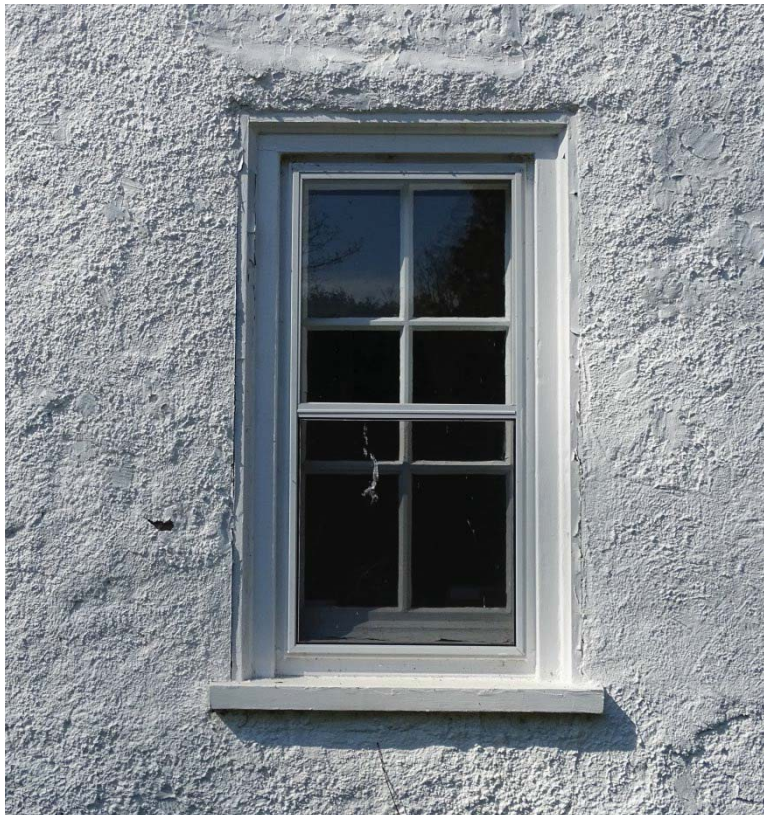
**Figure 74:** Transom on East Elevation

In similar fashion to the front elevation the east elevation has three, six-over-six wood hung windows – two at the 2<sup>nd</sup> Floor and one at the Ground Floor. In place of a fourth lower window, there is single, narrower window closely set to the rear lower window. There is also an arched window/transom located within the attic space of the gable end. At the rear and west elevations, the additions obscure the original fenestrations; however, given the style of architecture it is fair to assume that it was likewise symmetrical. Some of the painting, on both the windows and frames are chipping and spalling.

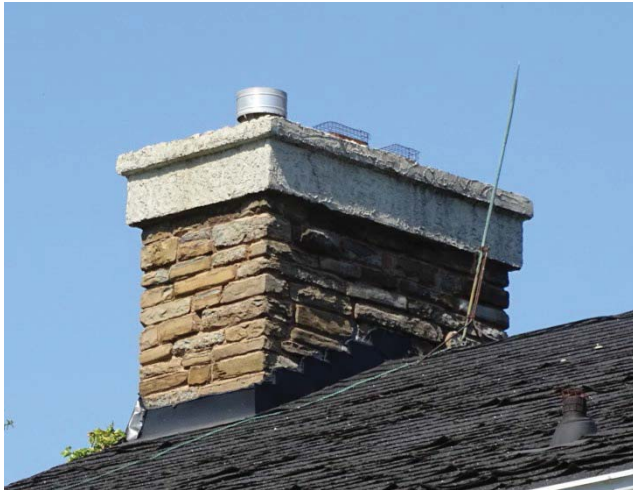
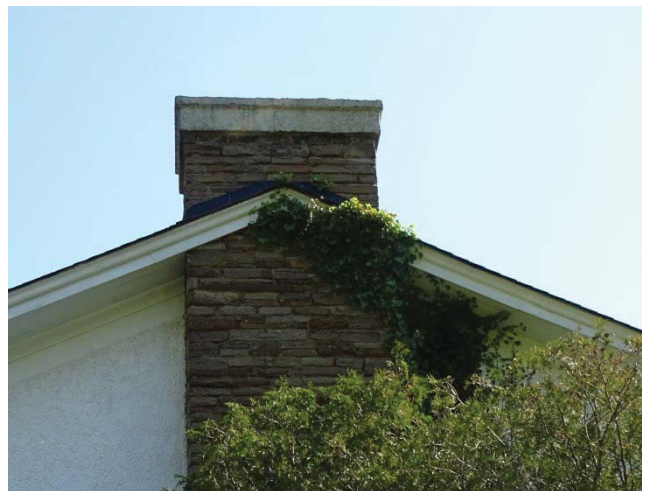
**Figure 76: Chimney**

Originally the house had two chimneys, one on each gable end. Archival photographs (**refer to Figure 30**) show both chimneys. During the renovations and rear addition constructed by Harry Ryrie in the 1920s, the second chimney on the east side of the house was likely removed. Presently, only the west chimney is extant. It is a brick chimney with a concrete cap and contemporary chimney exhausts, which may serve both the fireplace and mechanical equipment. Currently there is vegetative growth on the chimney. The chimney looked in fair condition. A second brick chimney exists within the two-storey rear addition and appeared to have been repaired/rebuilt at some point with a substantial concrete/stone cap and was in good condition.
