**Heritage Impact Assessment,
4243 Sixth Line, Town of Oakville,
Ontario**

FINAL REPORT

October 21, 2021

Project Number: 160940563

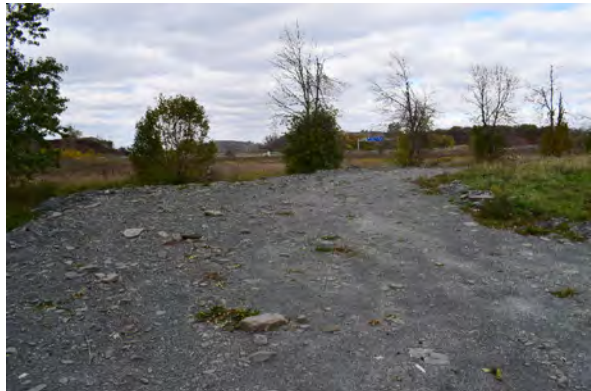
With the addition of fill to the site in the spring of 2018, the previous open landscape surrounding the barn has been altered. The fill dumped on the property surrounds the former barn. North of the former barn the fill has been compacted and acts as a laneway, while to the east of the former barn the fill is piled (Plate 8 to Plate 11). The fill has also been spread near the laneway to the Bell Mobility tower (Plate 12). The rolling agricultural fields that once surrounded the property are beginning to be altered with development. At the time of the site visit the property directly to the east was being excavated for development (Plate 13 and Plate 14). To the south, road work has been undertaken to open William Halton Parkway East from the Sixth Line to Trafalgar Road.

Plate 8: Fill west of the barn looking northeast, October 2018

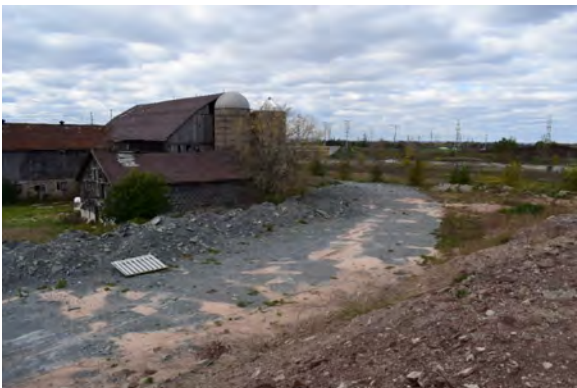
Plate 9: Fill east of the barn looking northwest, October 2018

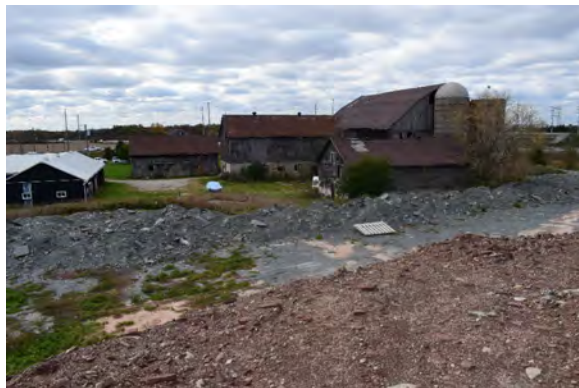
Plate 10: Fill east of the barn looking west, October 2018

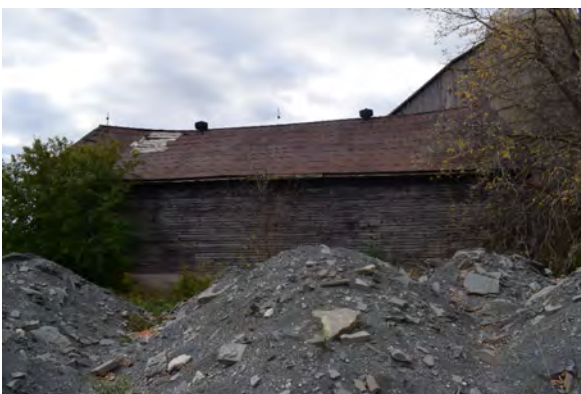
Plate 11: Close-up of fill east of the barn looking west, October 2018

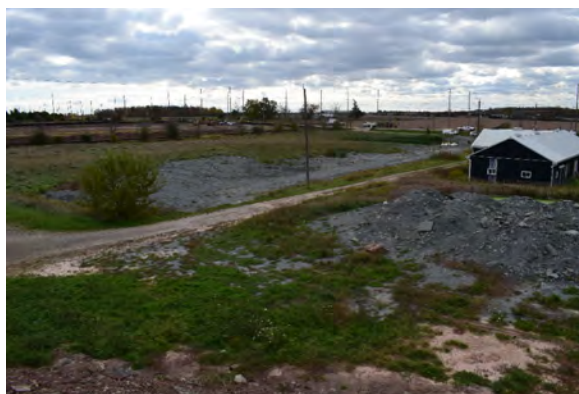
Plate 12: Fill on property looking southwest, October 2018

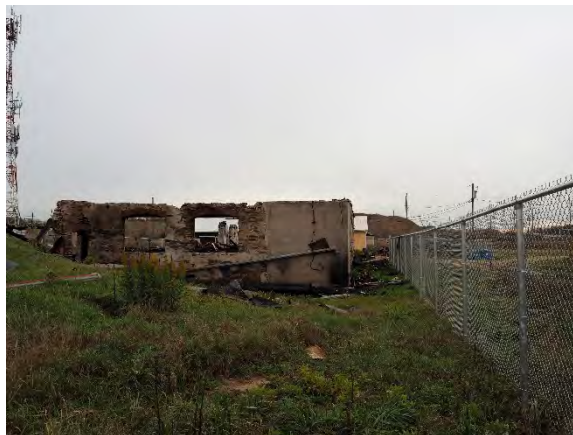
The barn, driveshed, chicken coop and silos were burned by a fire in July 2020. The barn foundation and silo ruins were subject to an assessment completed by Stantec in August 2020 (see Appendix E), which found that the timber part of the barn building, including roof, siding, floor, and structure of the second story, was completely burned beyond the possibility of repair. The ground floor perimeter walls of the barn were severely affected, including the complete collapse of some segments due to the disintegration of the mortar. The sections of the wall above the window/door's openings are in poor condition, some of them had already collapsed due to lack of support, since the wooden lintels were significantly affected or completely burned in some cases.

Plate 23: Barn foundation, November 2020

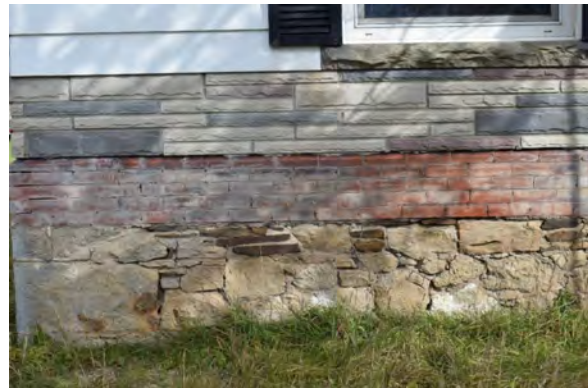
The residence built in 1898 is a two and a half storey structure with medium-pitched hip roof with asphalt shingles and two tall brick chimneys. The roofline has a single gabled dormer on its east elevation, and an overhang with a plain frieze. The frieze shows evidence of water stains where brackets were removed. The red brick residence is a rectangular shaped structure that fronts Sixth Line. The two-bay front (west) elevation has an asymmetrical entrance with a partial concrete porch with metal railings and an awning (Plate 24 and Plate 25). The front entry has a wood half glass door with decorative woodwork and a stone transom (Plate 26). The front elevation integrity was altered in the mid-20th century with the addition of vinyl siding and stone veneer cladding. The conserved red brick exterior is evident on the front elevation where the stone veneer has been removed (Plate 27). The front elevation has a central date stone that reads 1898.

Plate 27: Front elevation exterior layers and foundation looking east, October 2018

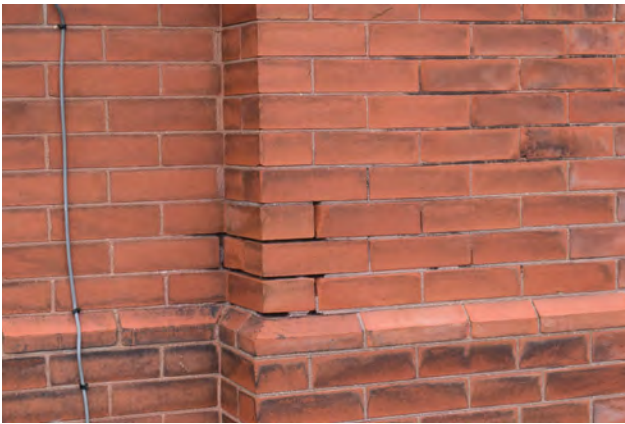
Visual assessment of the residence indicates that there are localized areas of wear and damage, including mortar recession, brick cracking foundation cracking and shifting stones, water stains, and weathered shingles (Plate 33 to Plate 40).

Plate 34: South elevation evidence of mortar receding and falling from joints, October 2018

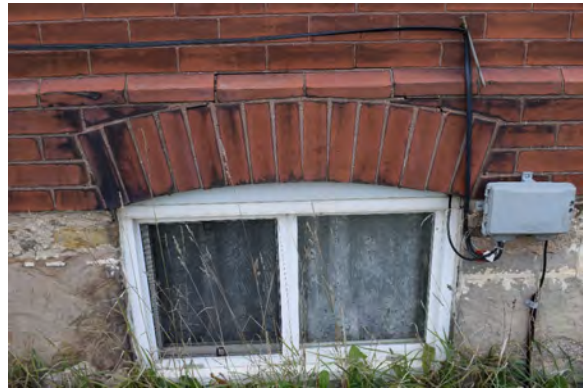
Plate 39: North elevation basement window, October 2018

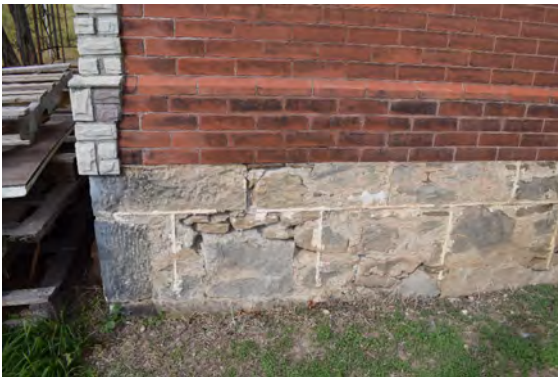
Plate 40: Close-up of south elevation foundation, October 2018

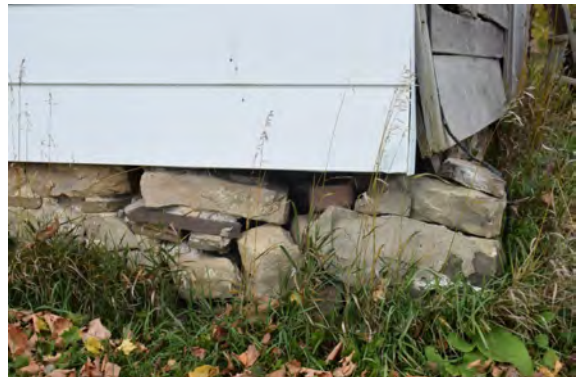
Plate 41: Southeast corner foundation of frame tail, October 2018

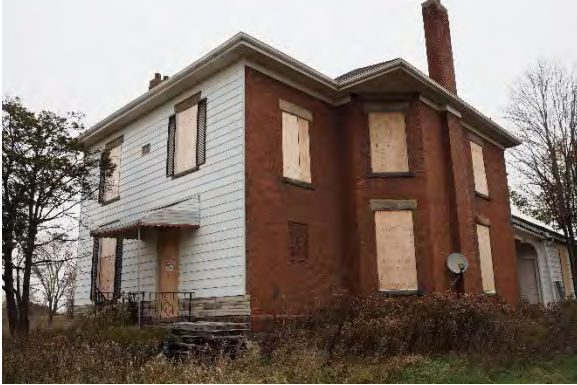
Photo courtesy of Bell Mobility,
2020

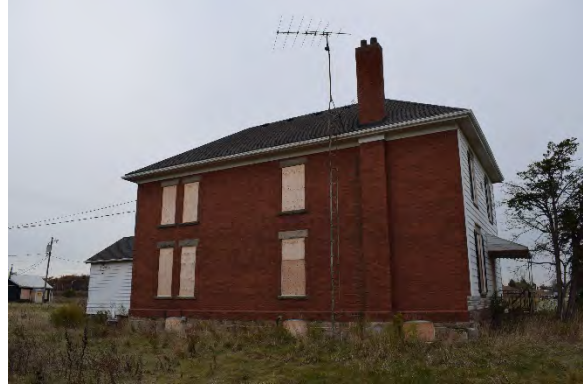
**Plate 44: View of south and west elevations.
November 2020**

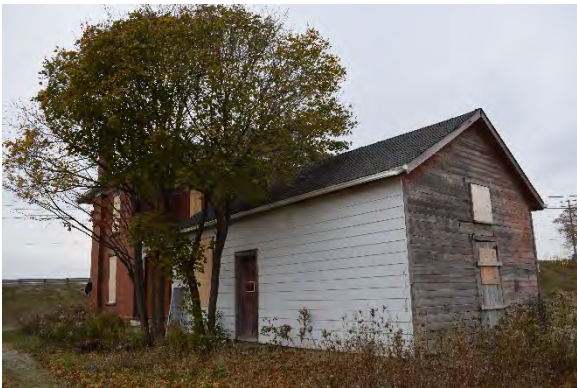
**Plate 45: View of east elevation, November
2020**

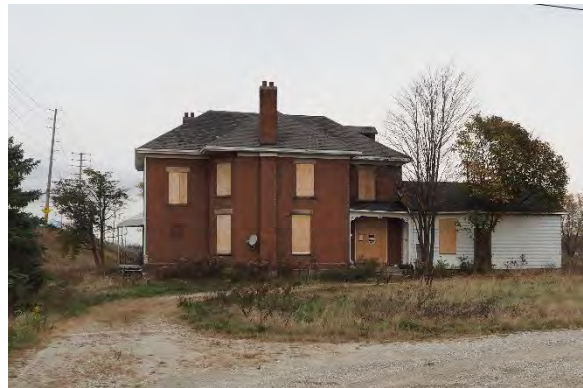
**Plate 46: View of frame tail, looking northeast.
November 2020**

One-storey frame tail, built on a rectangular plan and set on a fieldstone and concrete foundation	Poor	<ul style="list-style-type: none"> Maintained massing, and plan, however, the materials are showing signs of wear and damage The fieldstone foundation has crumbling sections (Plate 36) The wood cladding is weathered, and pieces are missing The east elevation wood half glass entrance door is falling out of its frame The north elevation roofline has missing shingles that has created a hole in the roof to the interior

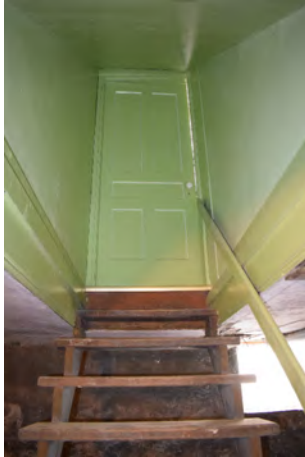
Plate 63: Basement stairs looking up towards first floor, October 2018

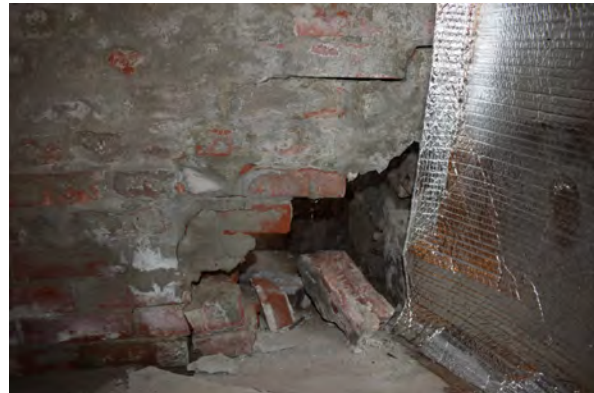
Plate 70: Hole on the interior brick wall, October 2018

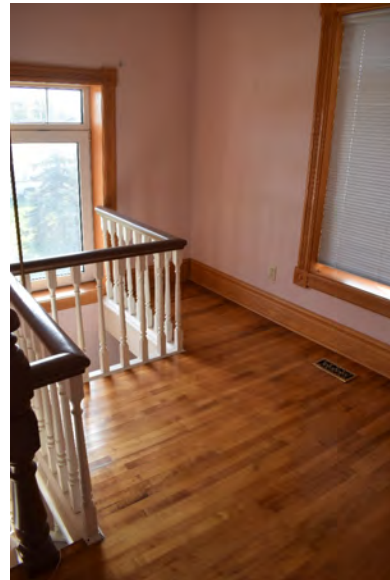
The second floor of the residence has a central hall plan with rooms north and south of the hallway (Plate 64). When the Schulz family purchased the house in 1985, they altered the layout of the upstairs rooms, which included a greater number of smaller rooms. With the changes in the 1980s few of the original features remain on the second floor, except for the wood flooring, which appears original to the residence. From the main staircase landing, the north side of the hallway has two bedrooms, the south side has two bedrooms, and at the end of the hallway is the bathroom and a closet (Plate 65). Access stairs to the attic are near the end of the hallway. The first bedroom on the south side has severe water damage above the closet door that has resulted in stains and mould (Plate 66 to Plate 68). The source of the problem is the missing roof shingles on the southeast end of the roof. Other minor water damage can be seen on the adjacent south bedroom ceiling and in the bathroom on the walls and ceiling (Plate 69 to Plate 71). The main hallway bends north near the bathroom, towards the laundry room and servant's staircase. The laundry room wall has some cracking (Plate 72). The servant's staircase to the kitchen have been covered in carpet (Plate 73). Based on photographs provided by Bell Mobility, trim around windows and doors has been removed from interior rooms, and the staircase railing and balusters have been damaged (Plate 74).

Plate 74: Second floor landing off main staircase, October 2018

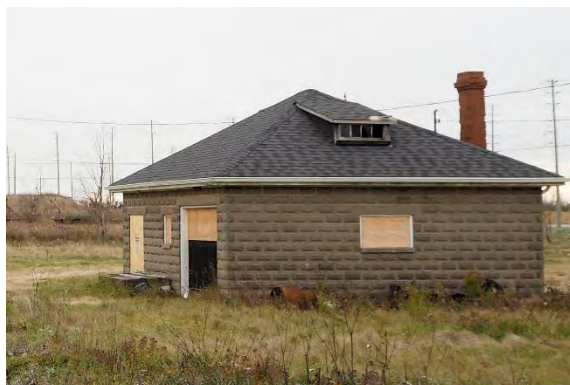
Plate 97: Milk house looking west, November 2020

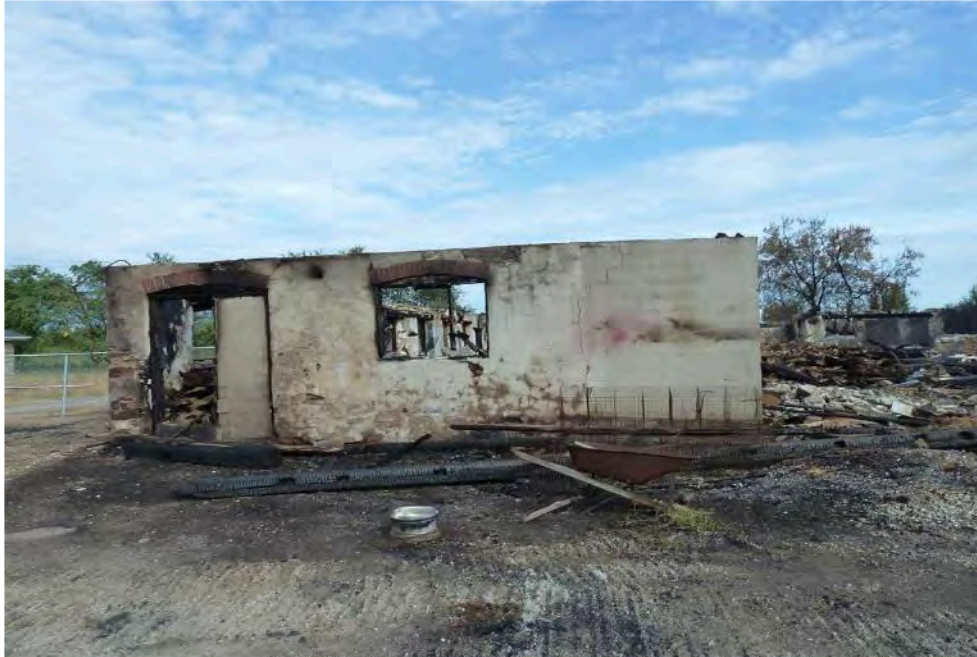
Photo 1 – Barn – East Side Exterior

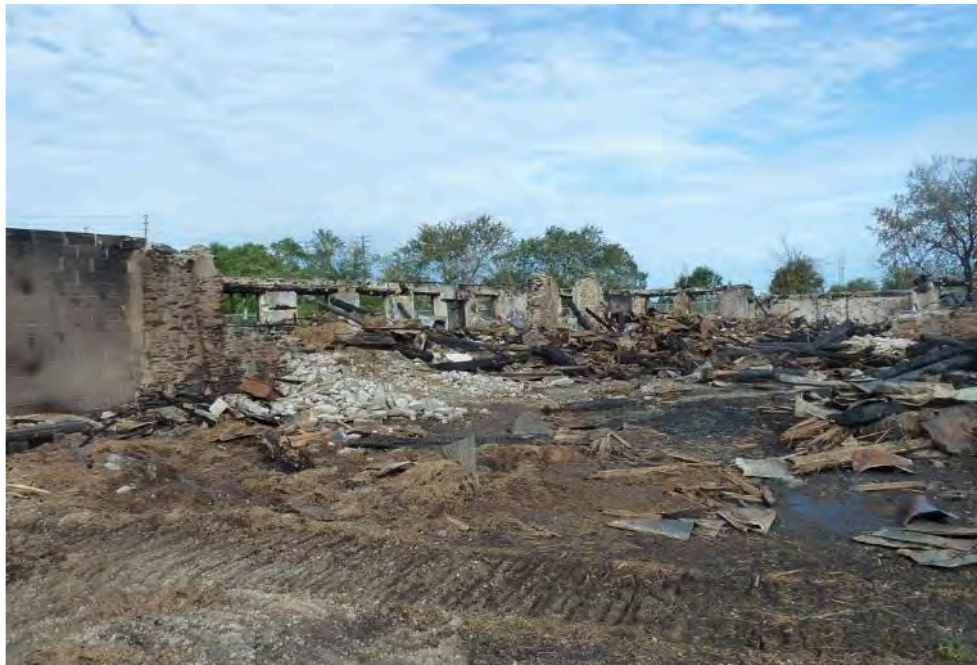
Photo 2 – Barn – NE Corner Exterior

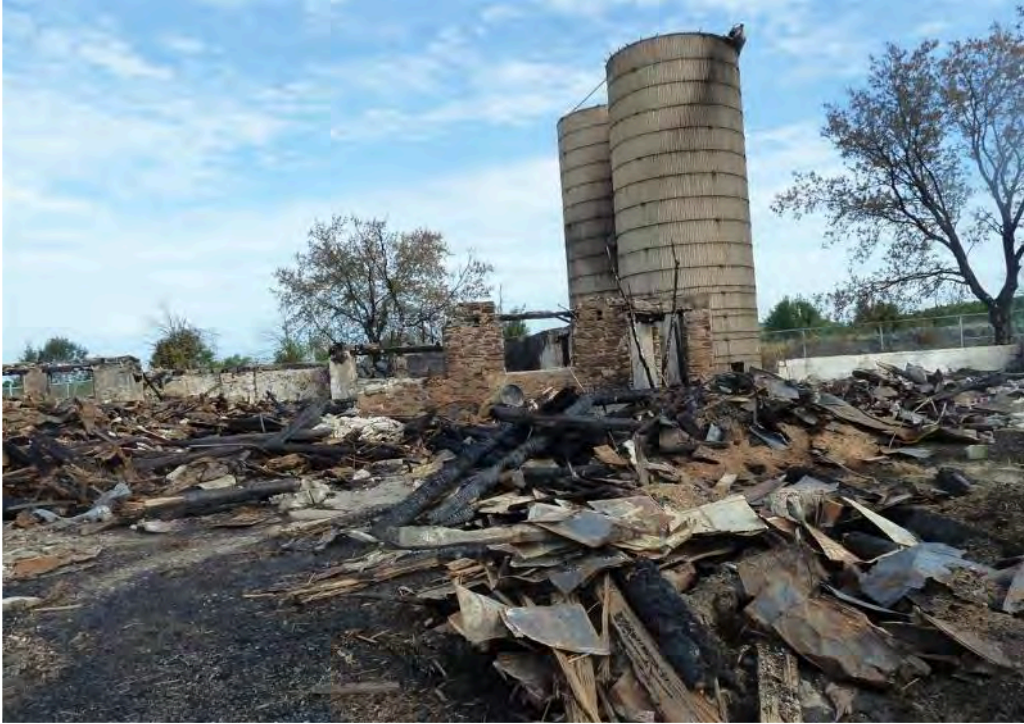
Photo 3 – Barn & Silos – NE Side Exterior

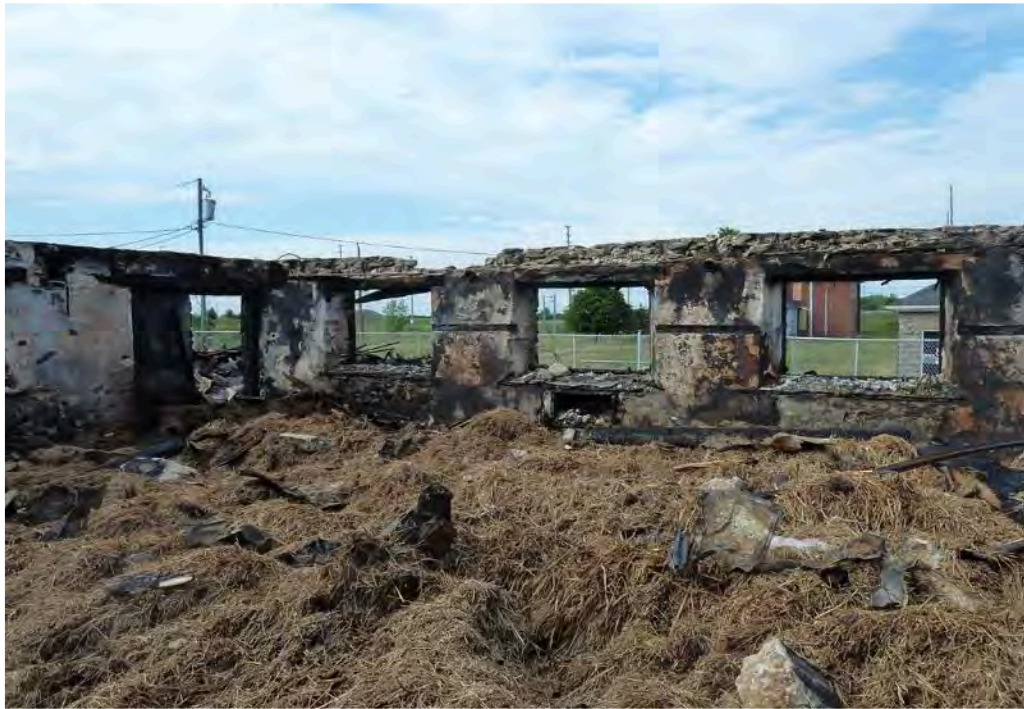
Photo 4 – Barn – SE Corner Interior

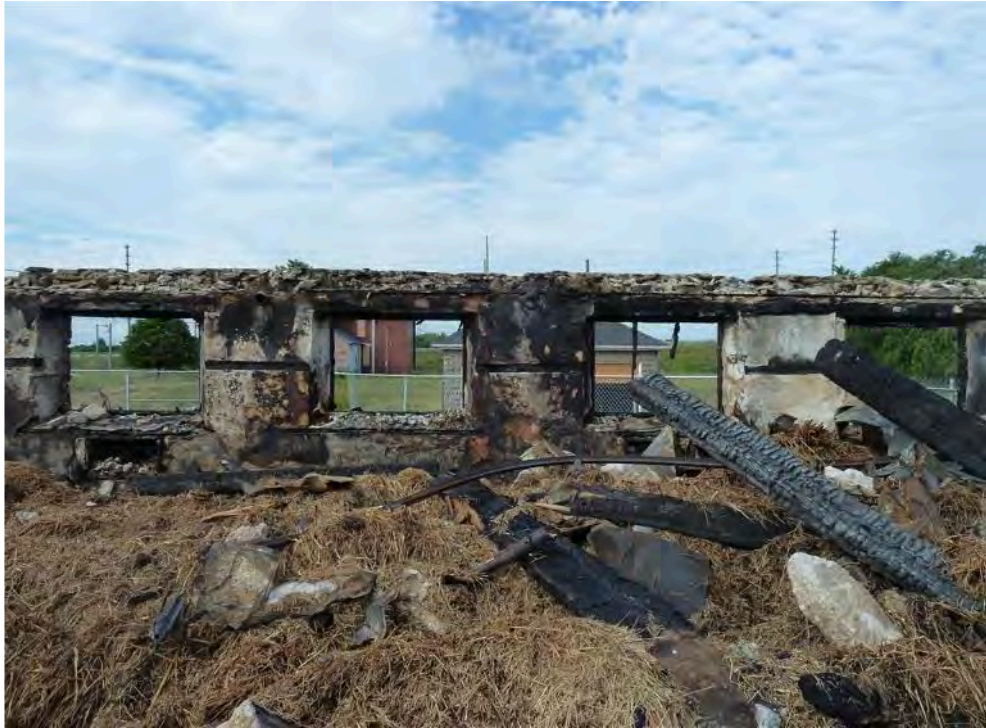
Photo 5 – Barn – South Side Interior

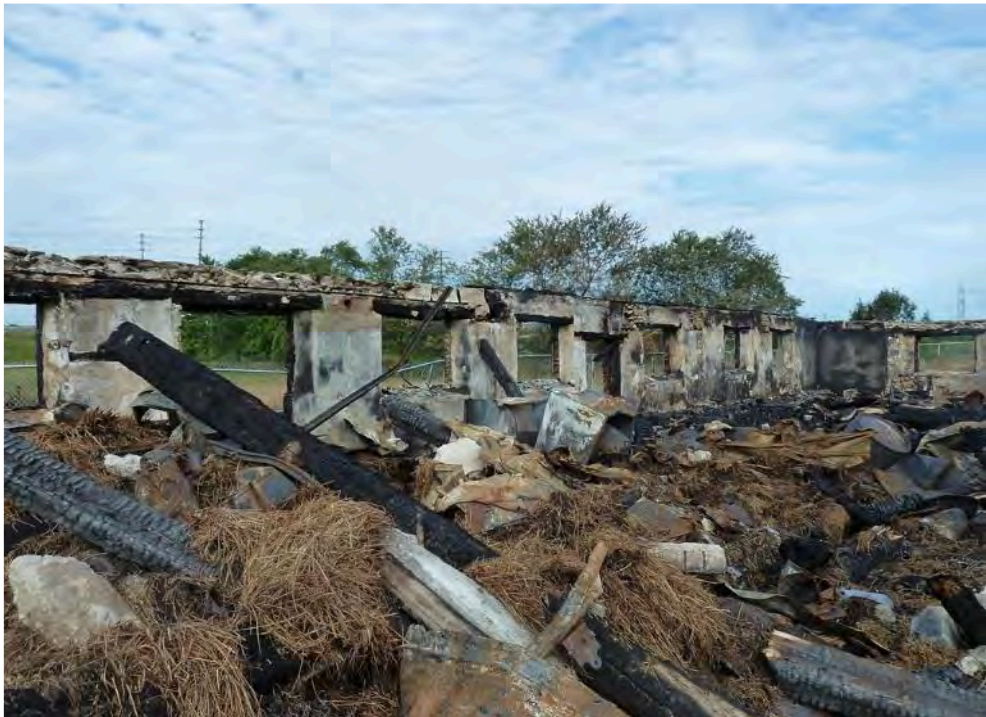
Photo 6 – Barn – SW Side - Interior

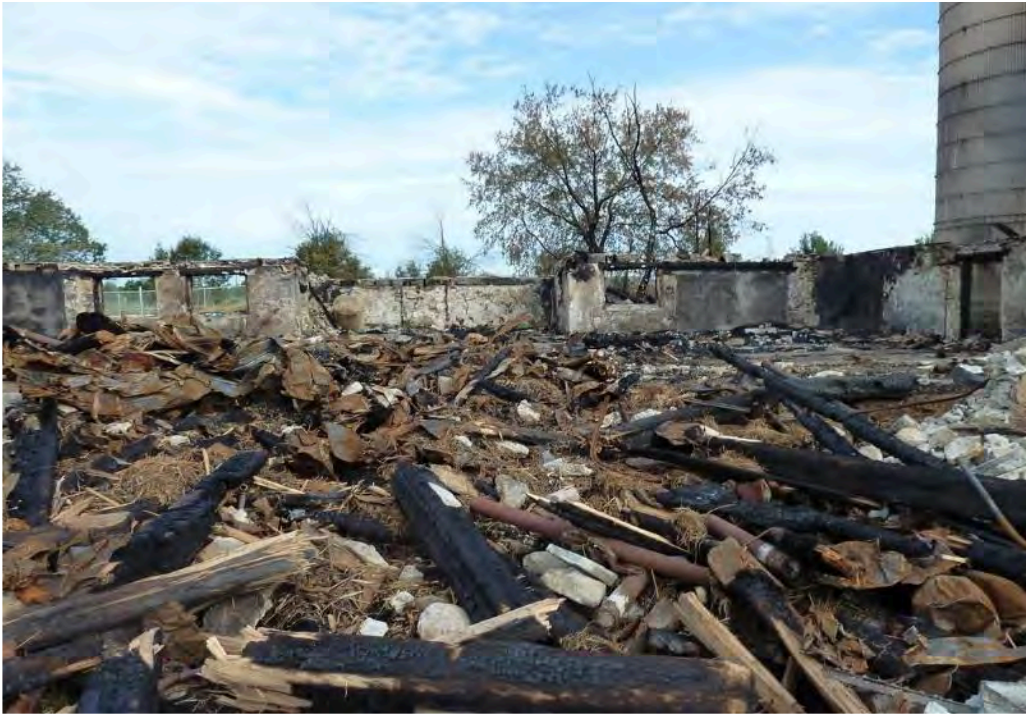
Photo 7 – Barn – West Side Interior

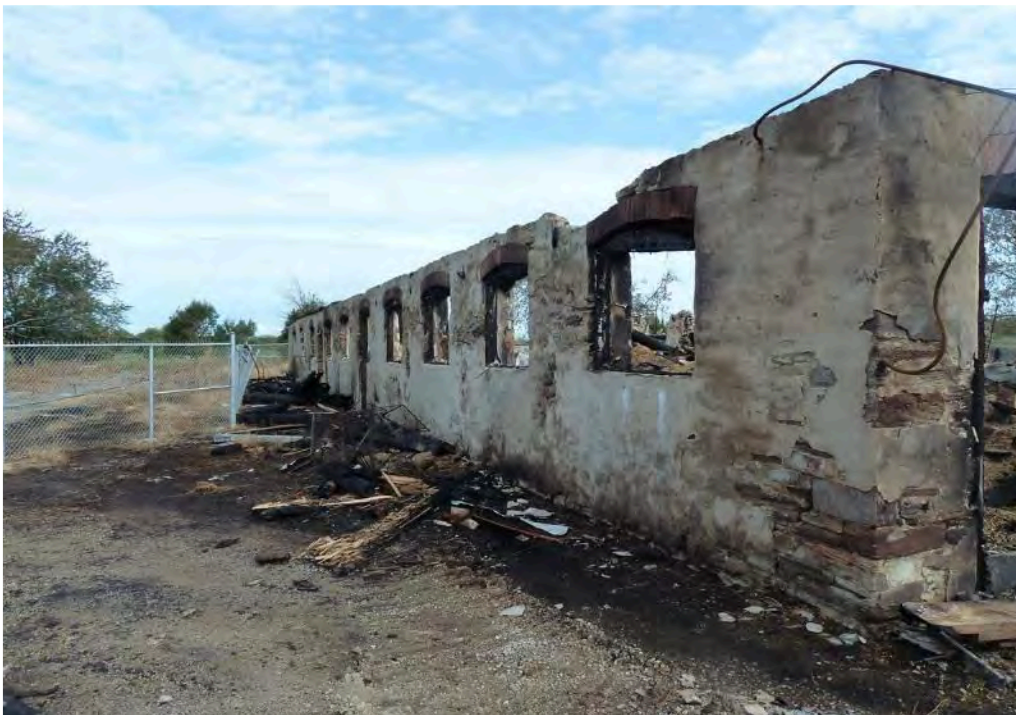
Photo 8 – Barn – South Side Exterior

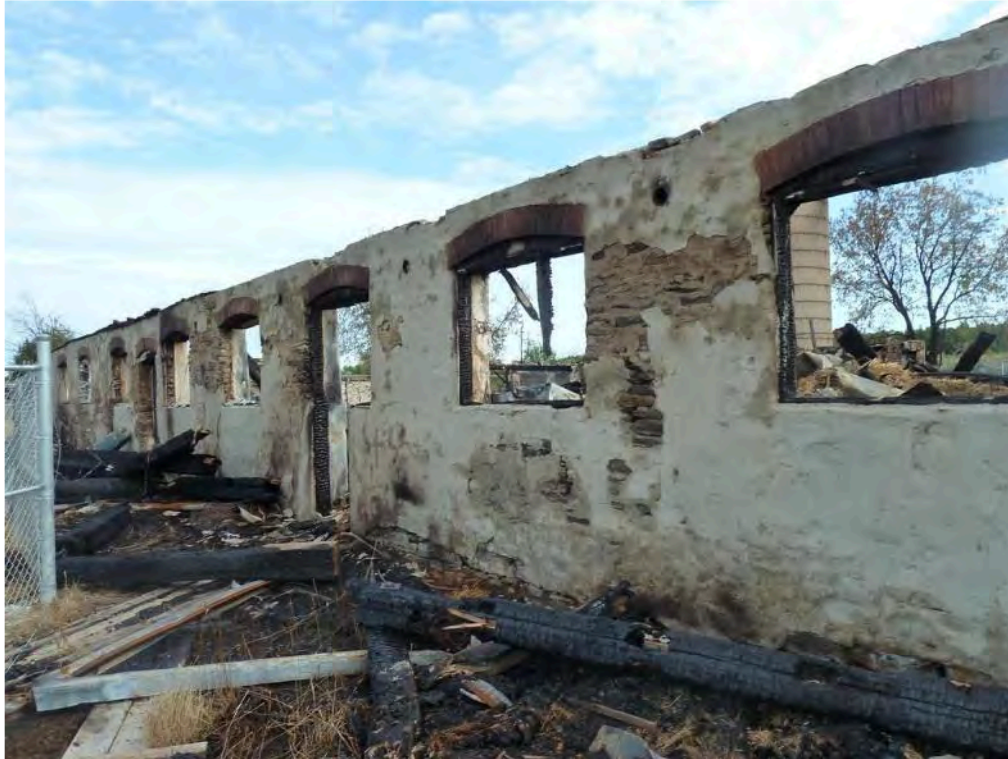
Photo 9 – Barn – South Side Exterior

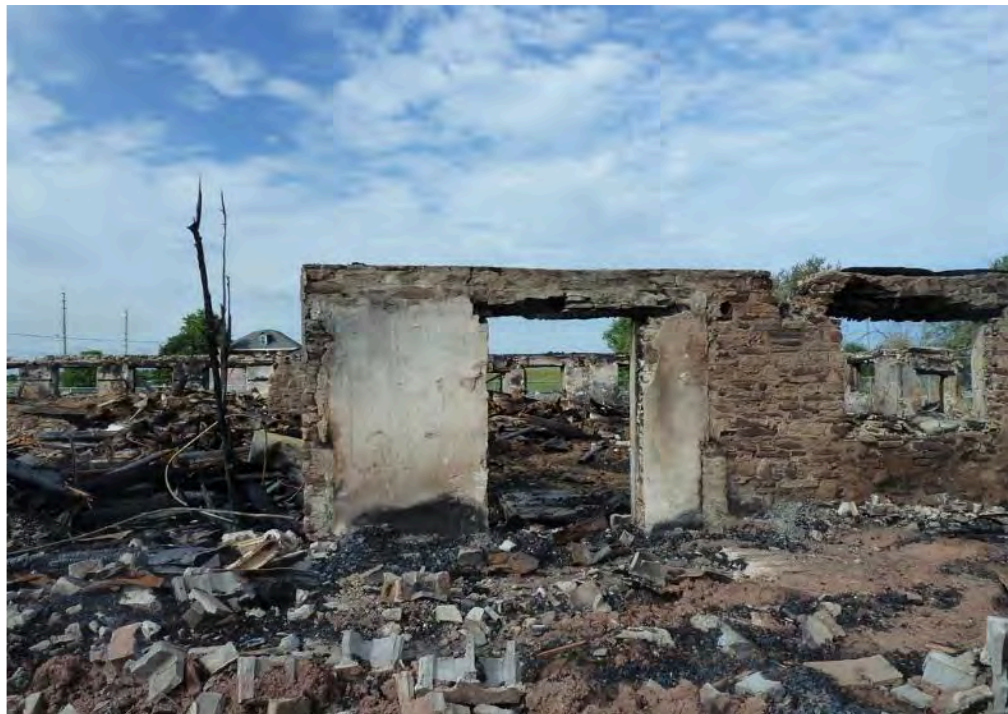
Photo 10 – Barn – North Side Exterior

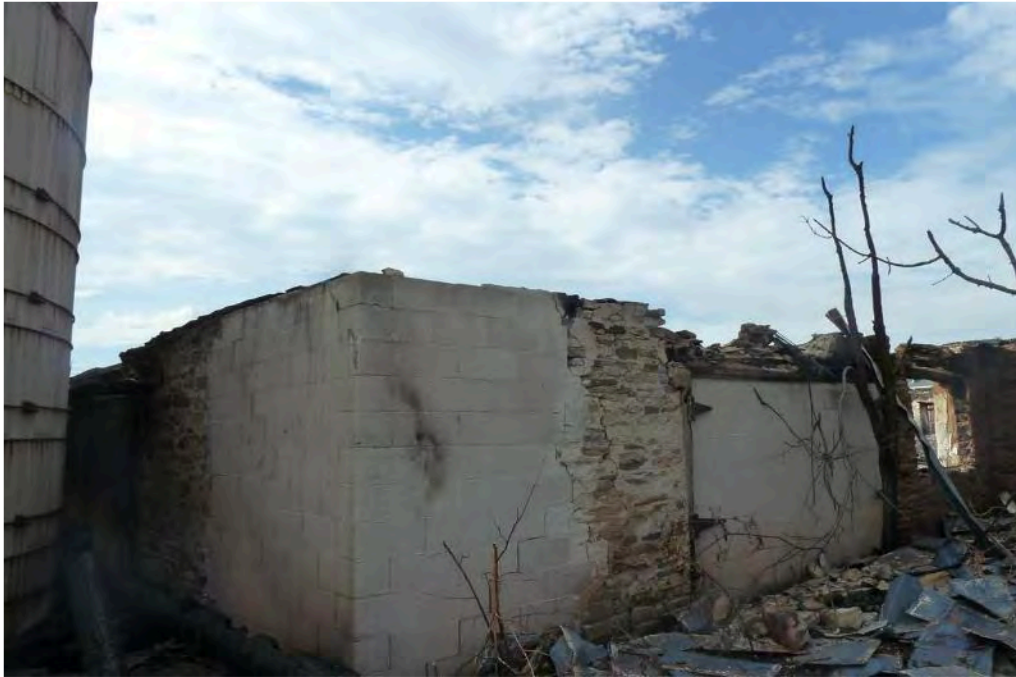
Photo 11 – Barn – NW Corner Exterior

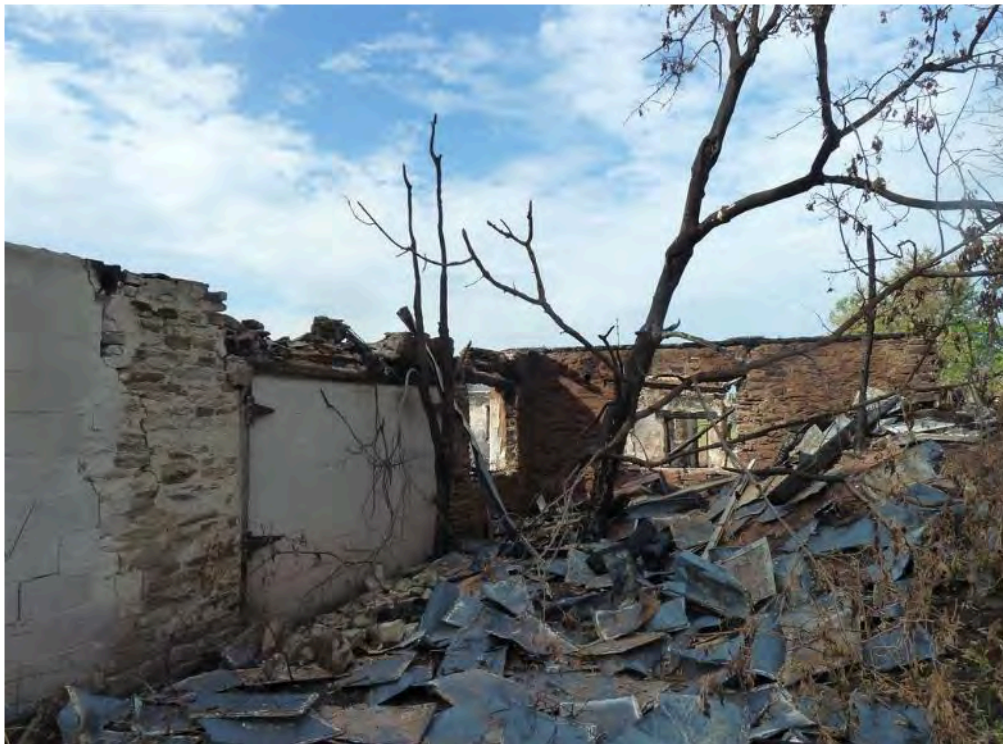
Photo 12 – Barn – NW Side Exterior

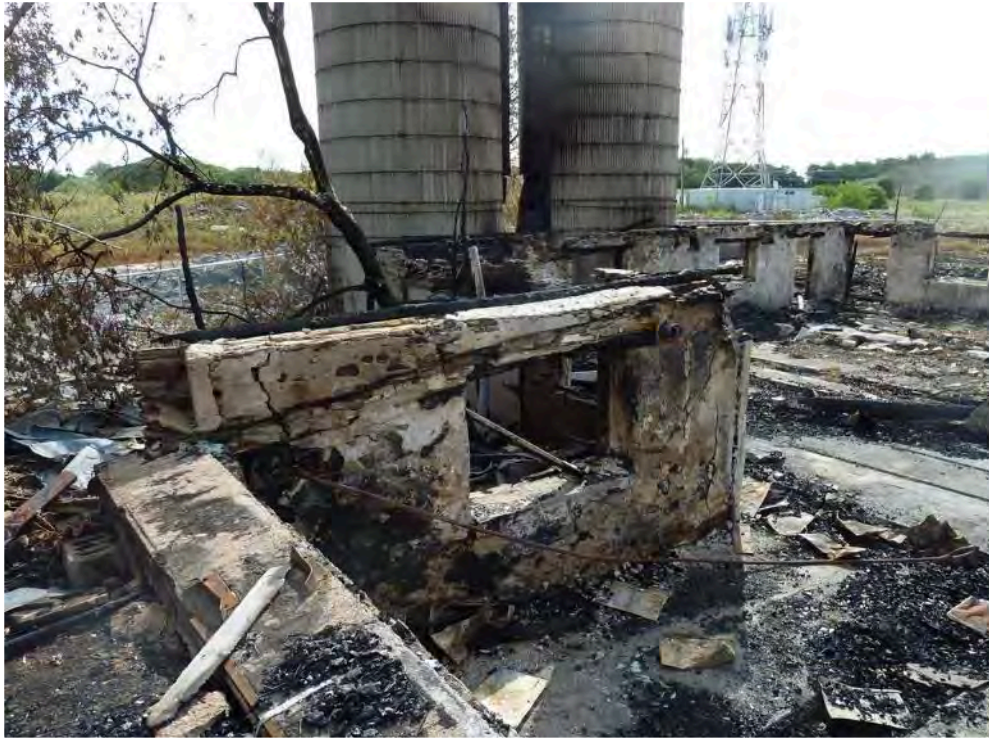
Photo 13 – Barn – West Side Exterior

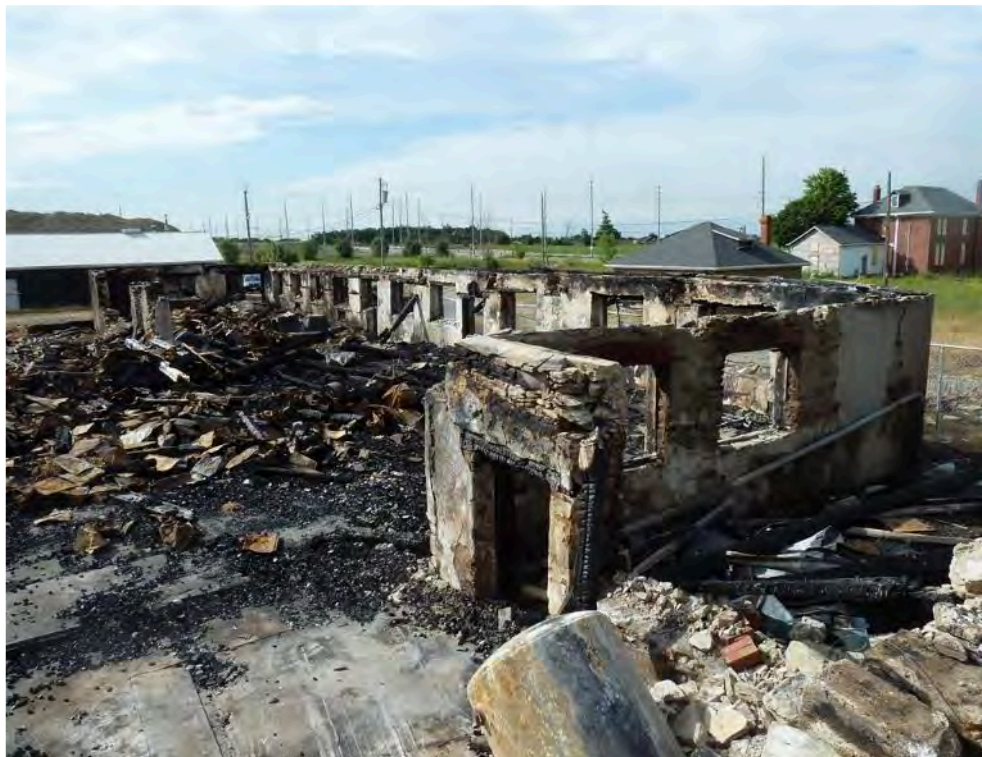
Photo 14 – Barn – SW Side Exterior

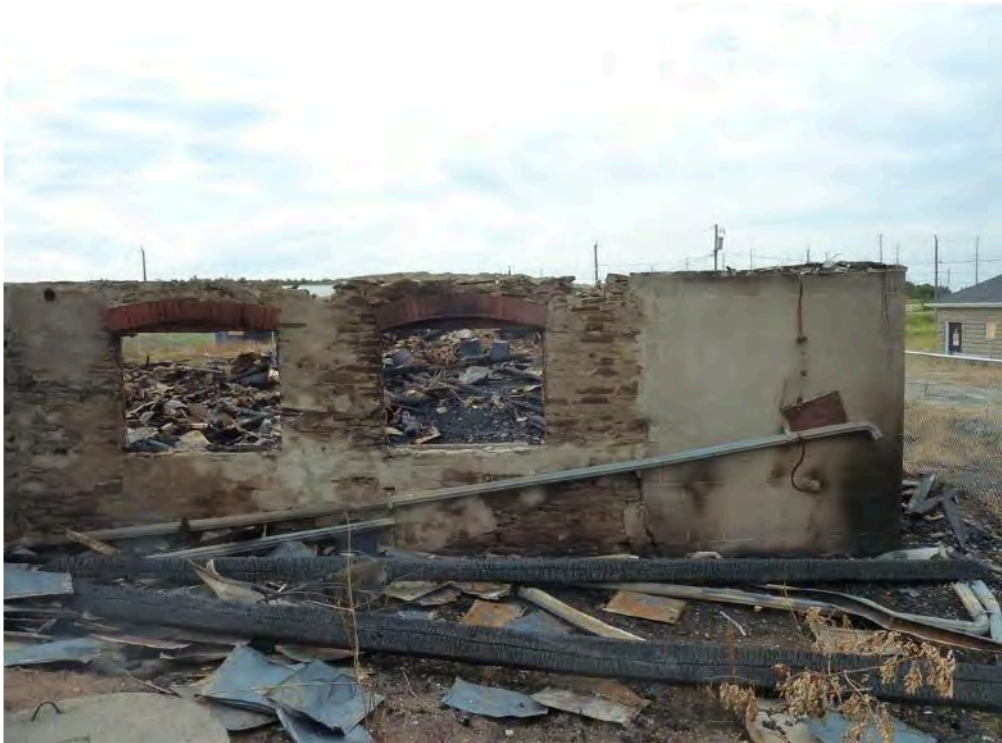
Photo 15 – Barn – SW Side Exterior

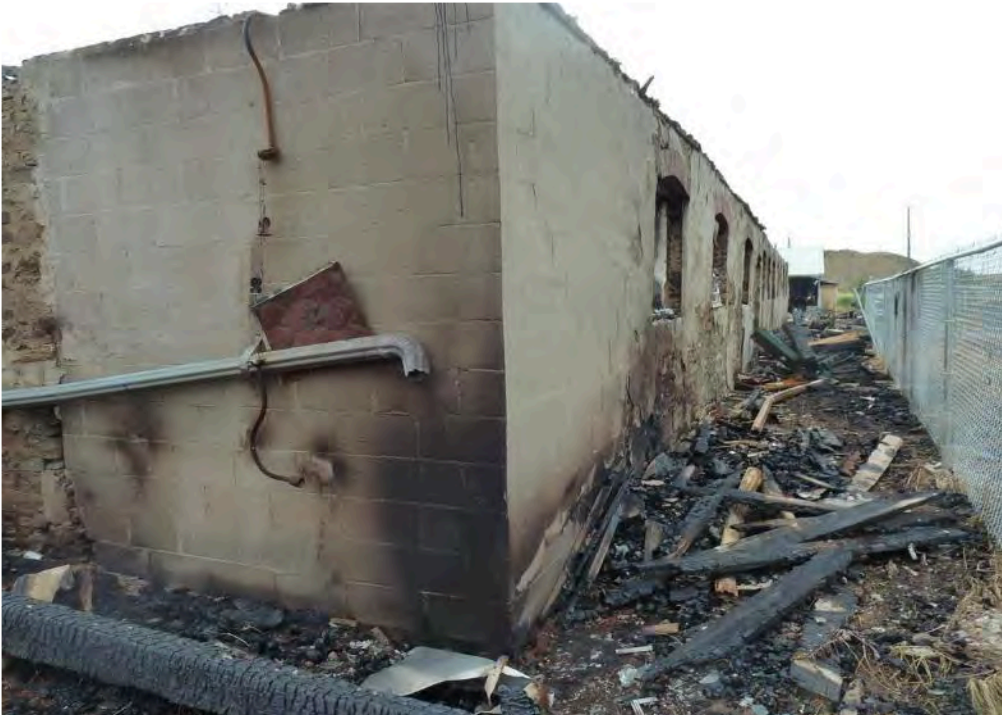
Photo 16 – Barn – SW Corner Exterior

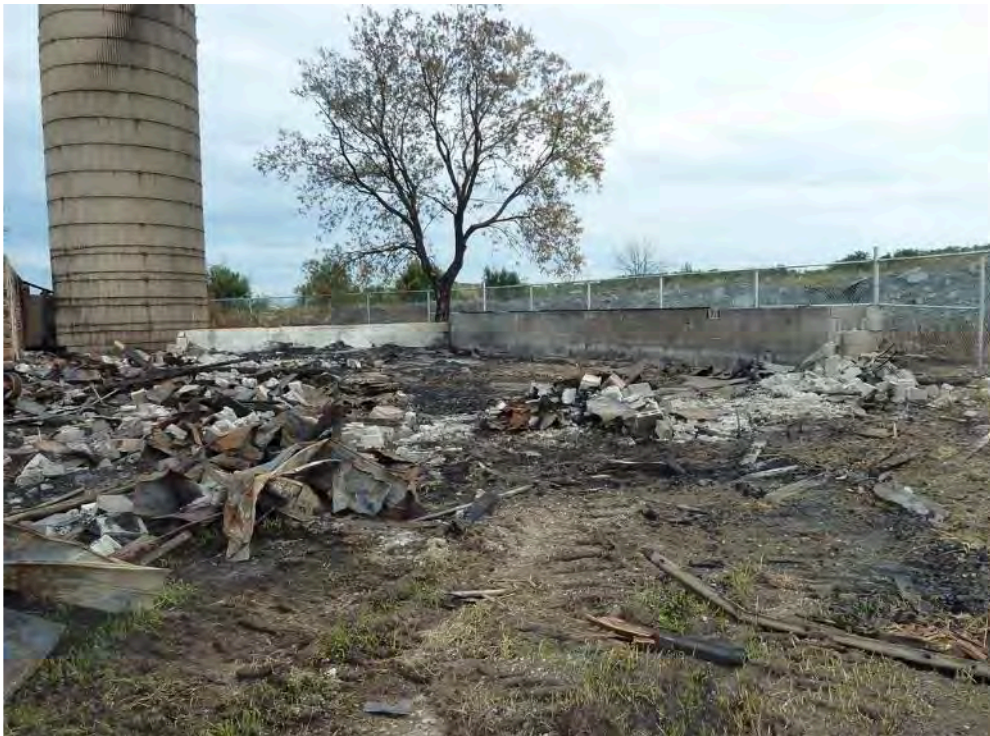
Photo 17 – Barn – NE Side Exterior

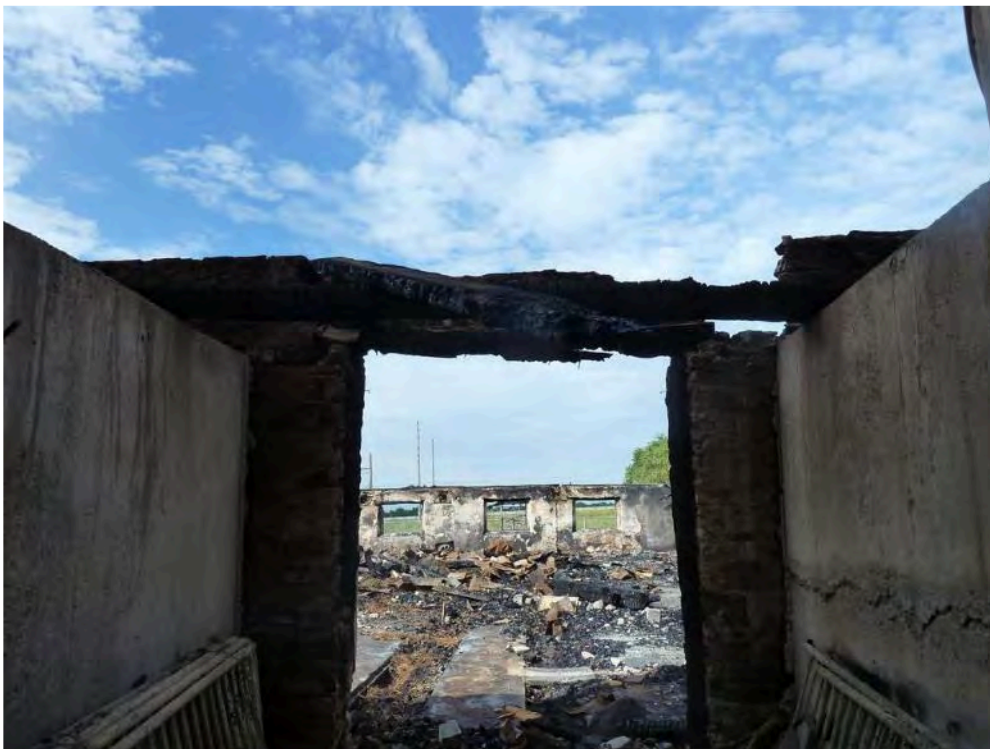
Photo 18 – Barn – North Side Exterior

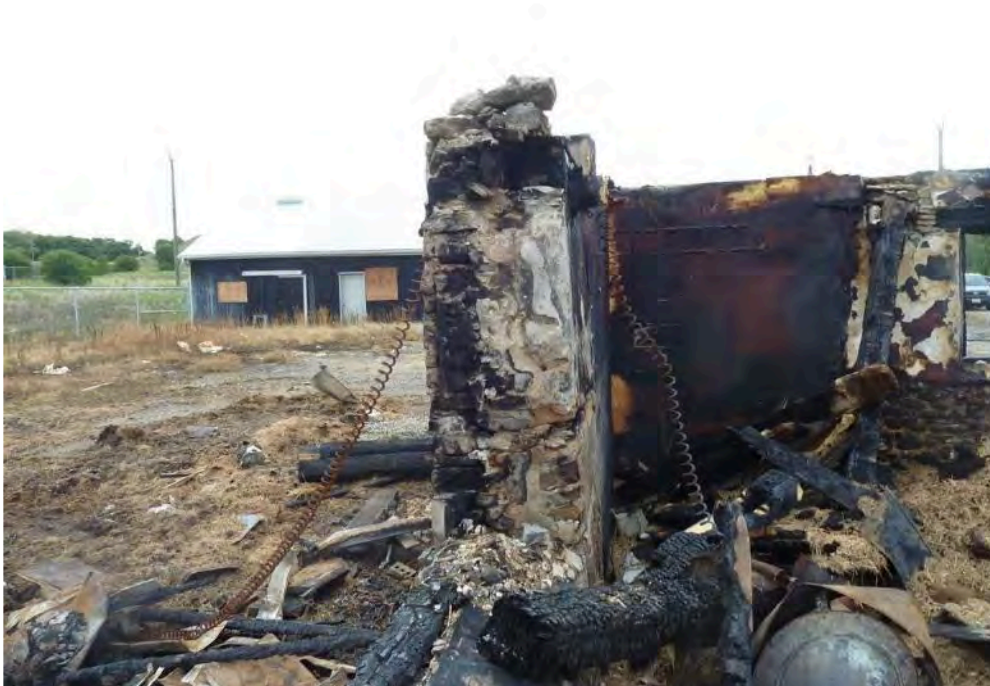
- ▶ The ground floor perimetral walls of the barn were severely affected, including the complete collapse of some segments due to the disintegration of the mortar (see photo 20). The sections of the wall above the window/door's openings are in poor condition, some of them had already collapsed due to lack of support, since the wooden lintels were significantly affected or even completely burned (see photo 21);

Photo 20 – Barn – NE Wall Section

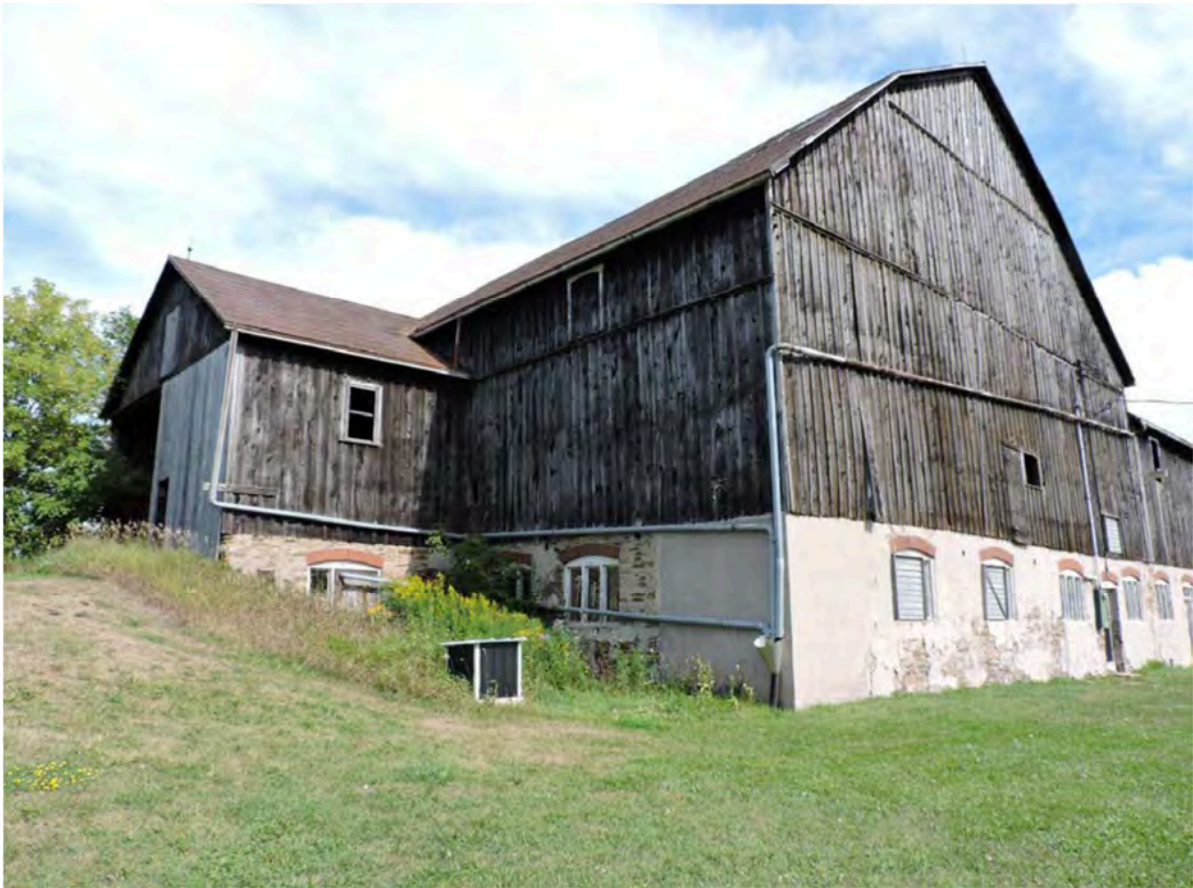
Photo 23 – Barn - Prior Condition (AB 2015, by Laurie Smith Heritage Consulting)
